SMITHSONIAN INSTITUTION BUREAU OF AMERICAN ETHNOLOGY BULLETIN 51

ANTIQUITIES OF THE MESA VERDE NATIONAL PARK

CLIFF PALACE

JESSE WALTER FEWKES

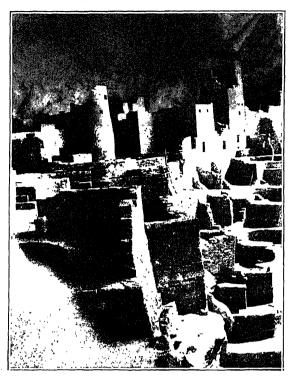
THE SOUTHERN END, AFTER AND BEFORE REPAIRING

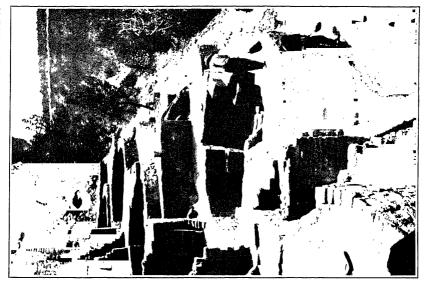
TERRACES AT SOUTHERN END, AFTER REPAIRING

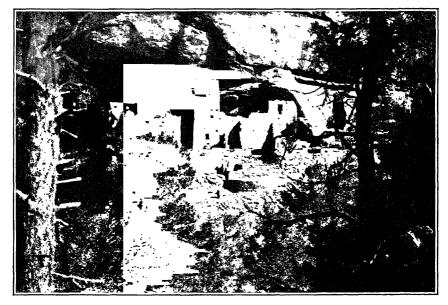
SQUARE TOWER, AFTER REPAIRING
